Home Inspection Report

Thursday, August 22, 2019

MATTERHORN PROPERTIES LLC

08222019

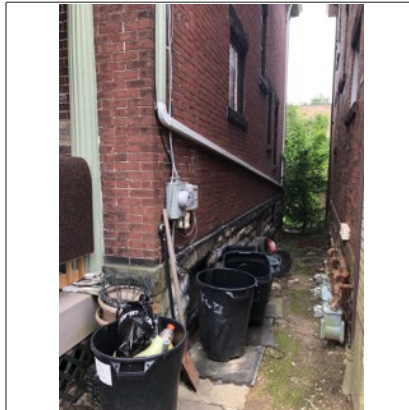
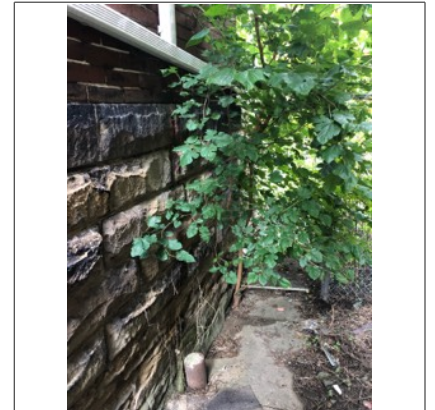
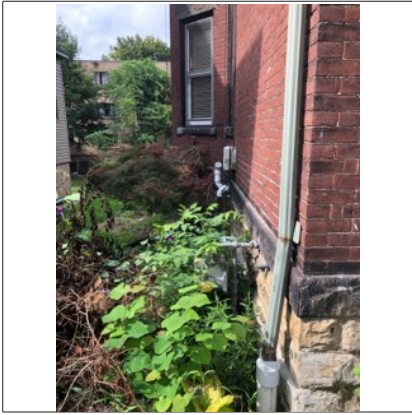
Recommend maintaining a positive drainage slope away from the foundation..

Recommend trimming trees/vegetation so it doesn't come into contact with home.

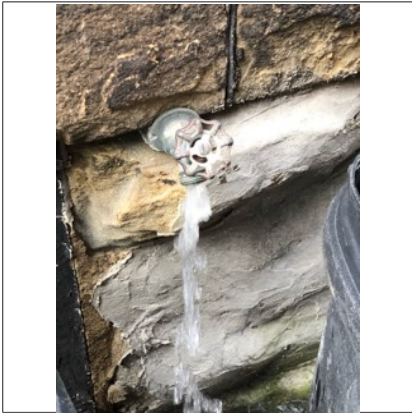
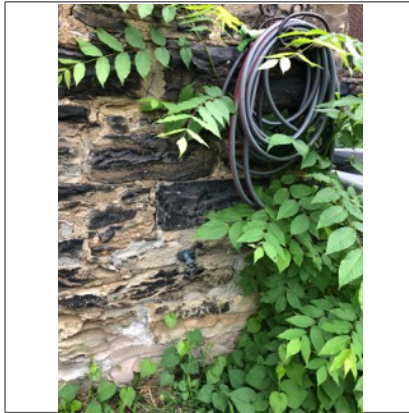
Hose bib(s) not frost-proof type, recommend turning off shut off valve inside of home to prevent freezing

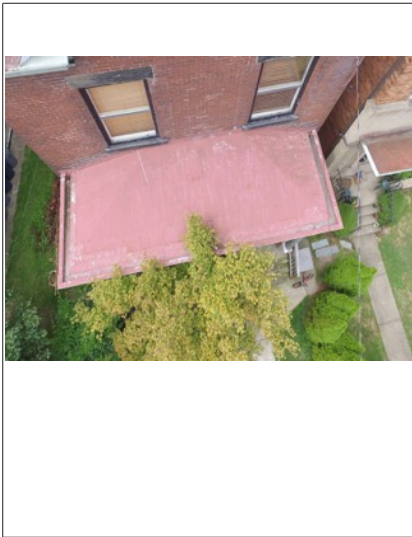
Poor flashing
Gutters in need of cleaning

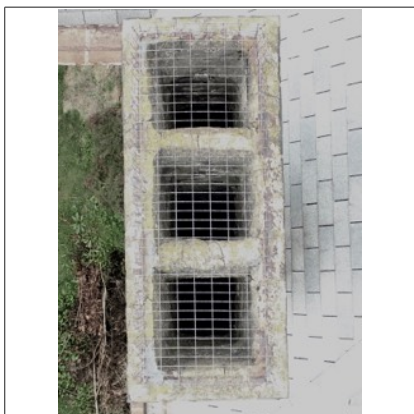
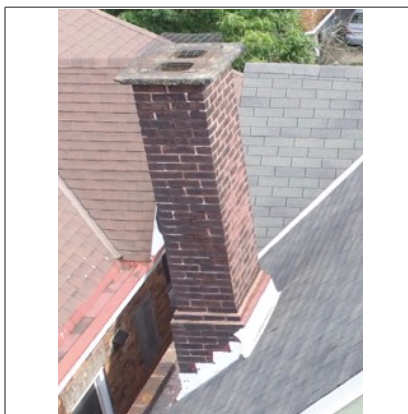
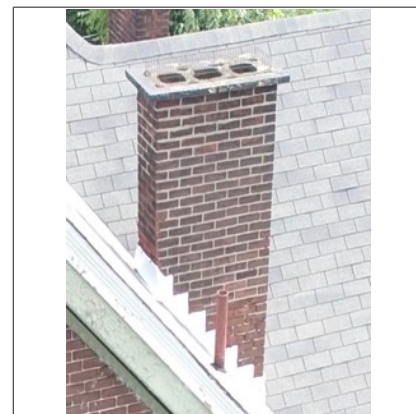
- None
Viewed From Roof Ladder at eaves Ground (Inspection Limited) With Binoculars DRONE
Rain Cap/Spark Arrestor Yes No Recommended
Chase Brick Stone Metal Blocks Framed
Evidence of Holes in metal Cracked chimney cap Loose mortar joints Flaking Loose brick Rust
 No apparent defects
Flue Tile Metal Unlined Not Visible
Evidence of Scaling Cracks Creosote Not evaluated Have flue(s) cleaned and re-evaluated
 Recommend Cricket/Saddle/Flashing No apparent defects
Condition Satisfactory Marginal Poor Recommend Repair
Comments Recommend installing rain cap/spark arrestor
 Chimney chase is unlined -
 recommend chimney sweep or mason evaluate

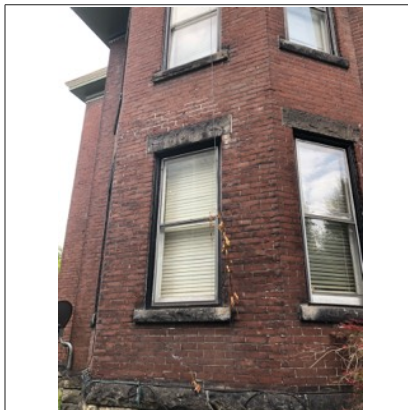
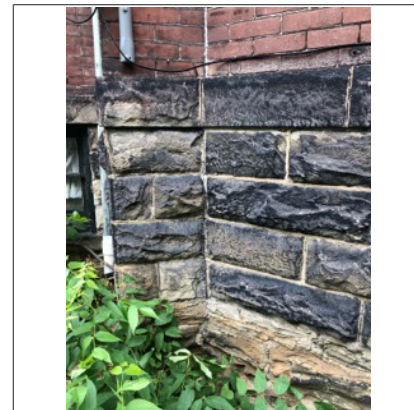
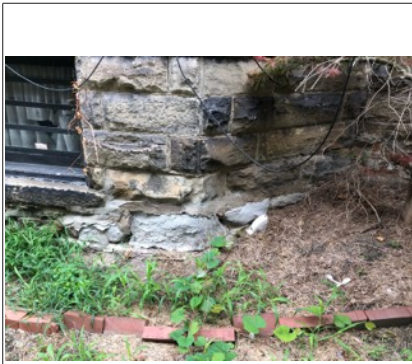
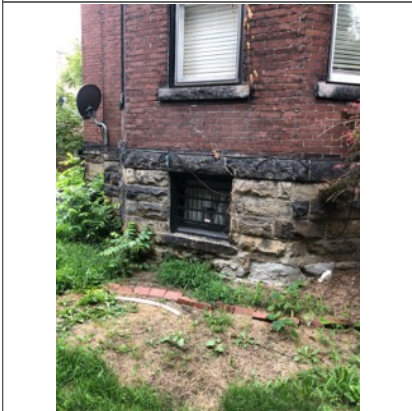
Brick and mortar had some cracking recommend repair

Normal caulking maintenance recommended

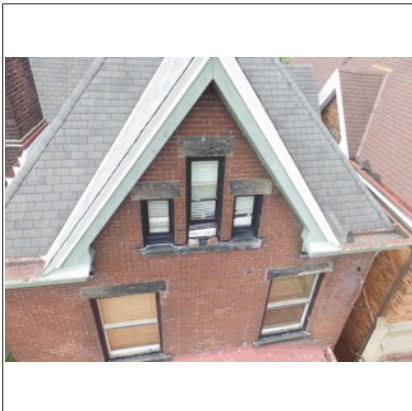
Comments Trim had some deterioration recommend repair and painting

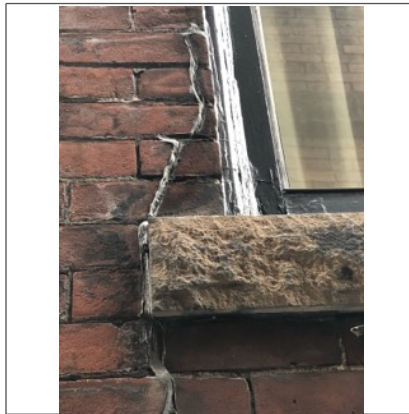
- None
 - Satisfactory Marginal Poor
 - Recommend around windows/doors/masonry ledges/corners/utility penetrations
- Comments Recommend caulking around windows, doors, corners, utility penetrations.

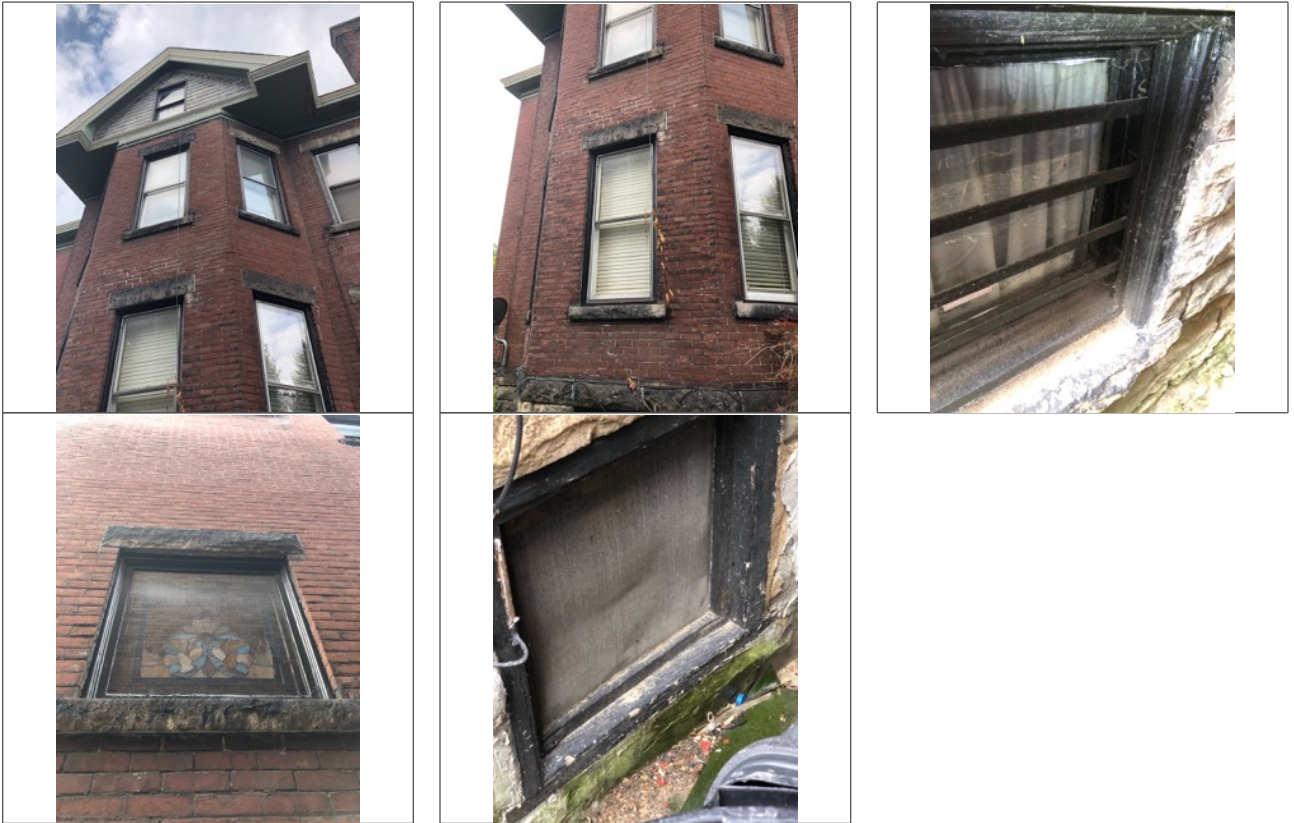
Window sills/trim have some damage recommend repair/replacement

Damaged wood present on the sills - recommend repair

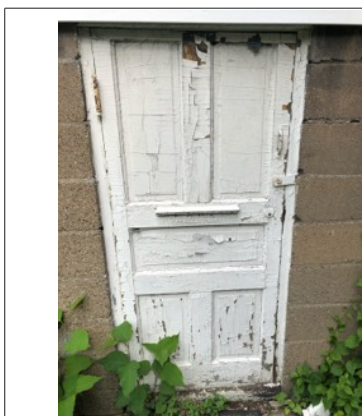
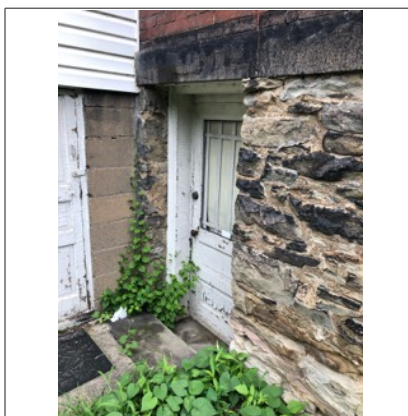
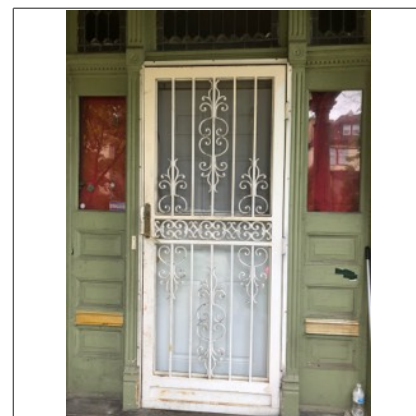
Comments Entry door weathered, recommend paint/stain to protect from further damage.

Front storm door doesn't have safety door closer

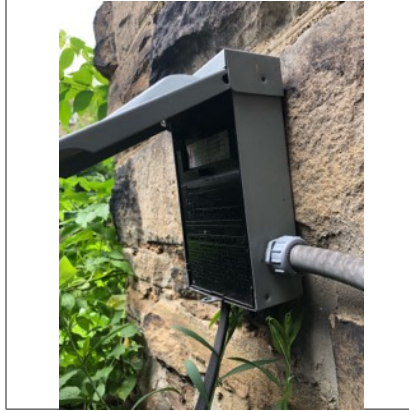
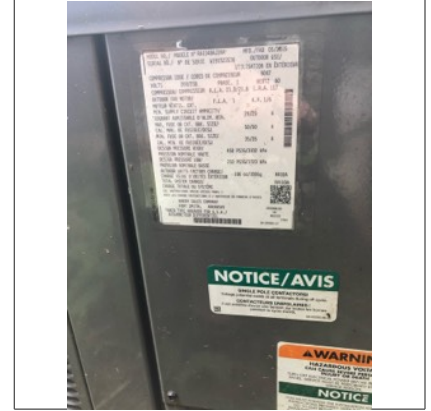
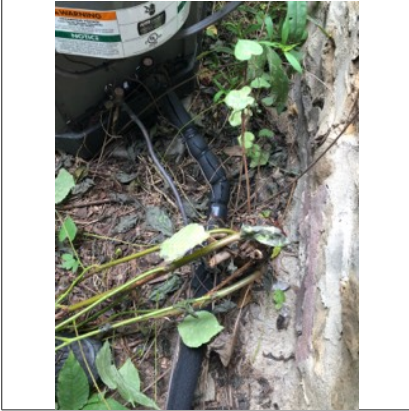
Comments Outside condenser unit coils dirty recommend cleaning.

Comments cont. Recommend trimming back bushes from around the condenser unit.

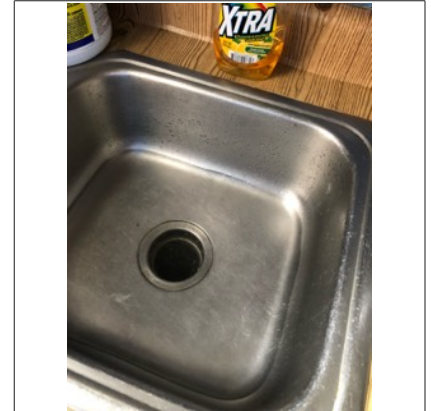
Left side of sink has no connection to drain. Connection is needed and proper P Trap installed. Sewer gases will enter living space until proper connection is performed

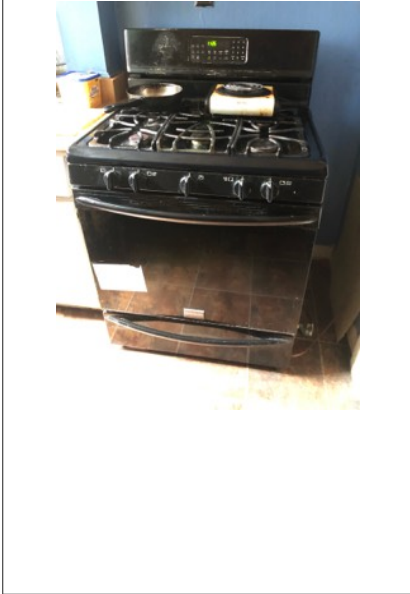
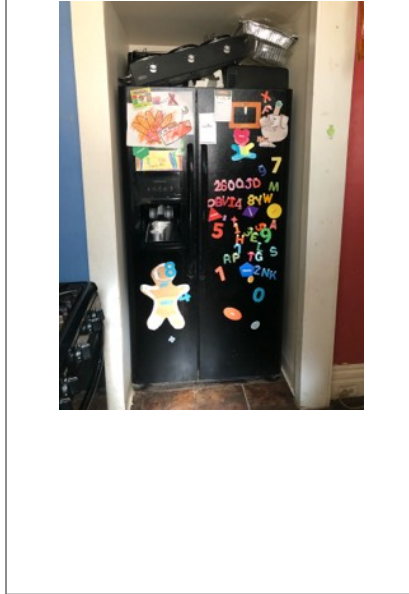
Comments Owner had power to kitchen off for electrical issue. Recommend electrician perform safety check. NO appliances were tested

Disposal was not tested due to power switched off at panel. Clearly the photo shows signs of leaking and rusted. Recommend plumber and or electrician replace.

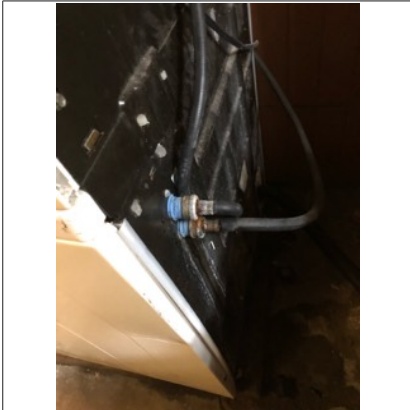
Washer located in basement. Connections are needed to be replaced due to signs of leaking.

Dryer located upstairs. There was no venting of dryer, recommend connecting dryer vent and venting to outside.

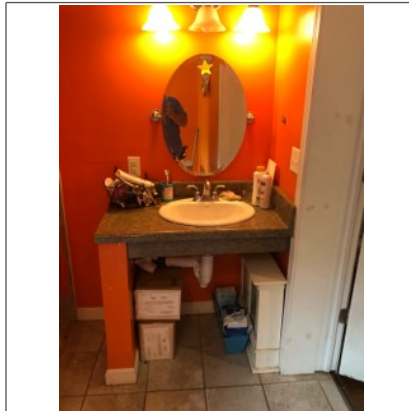
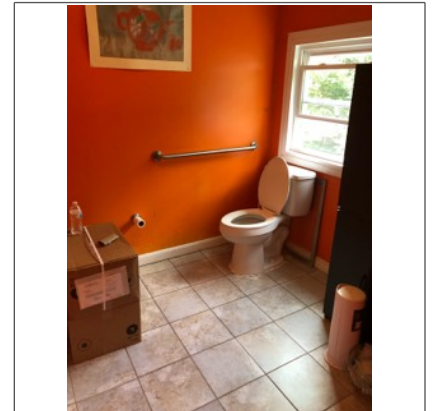
- Heat source present** Yes No
- Exhaust fan** Yes No Operable: Yes No Noisy
- Comments** Moisture stains present.
Damaged walls recommend repair
Damaged ceiling recommend repair
Recommend venting exhaust fan to exterior
Several areas on the ceiling and walls have active moisture stains, recommend roof/gutters repaired and walls/ceiling repaired.

Water damage

Water damage and staining

Water damage and moisture present.

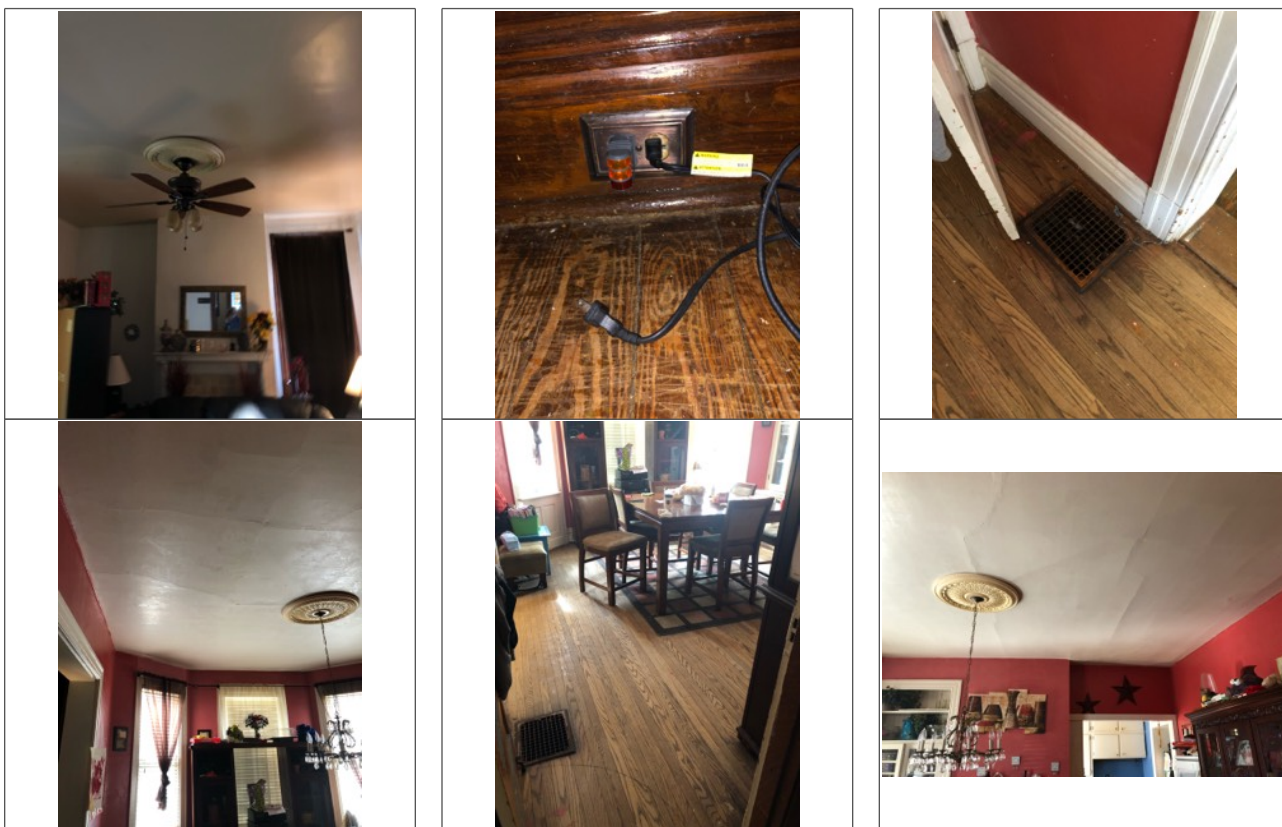
Comments Walls and ceiling contain chipped paint and cracking in plaster. Recommend repair and paint

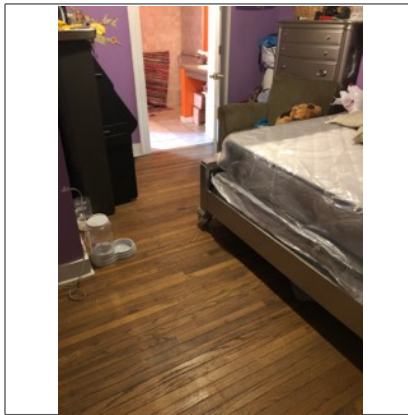
Comments Holes in wall/ceiling recommend repair

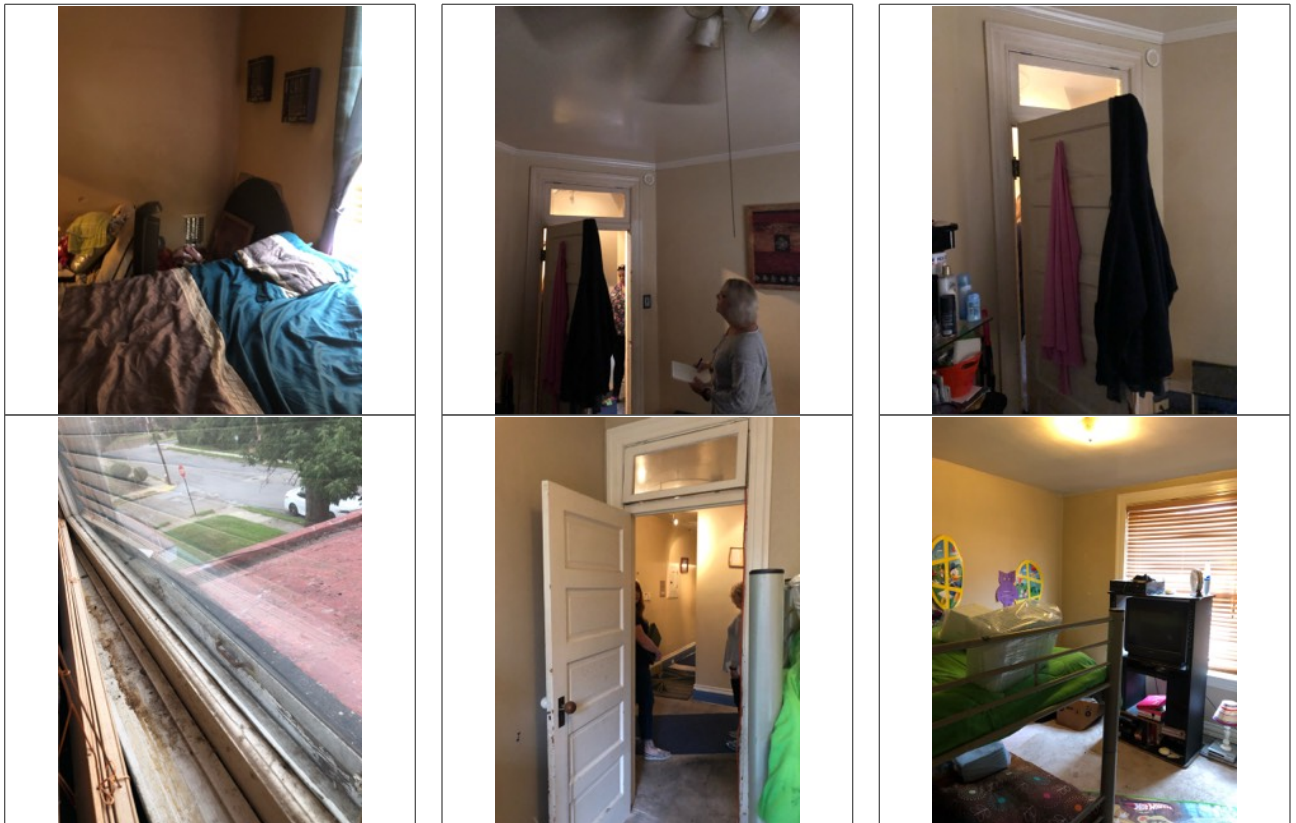
Comments Several rooms upstairs have holes/cracks in plaster on walls and ceilings. These cracks appear to be typical of a 100 year old house with limited maintenance. Recommend repair and painting throughout house.

Windows appear to be original and are mostly passed their expected life, recommend budgeting for window replacement as soon as possible

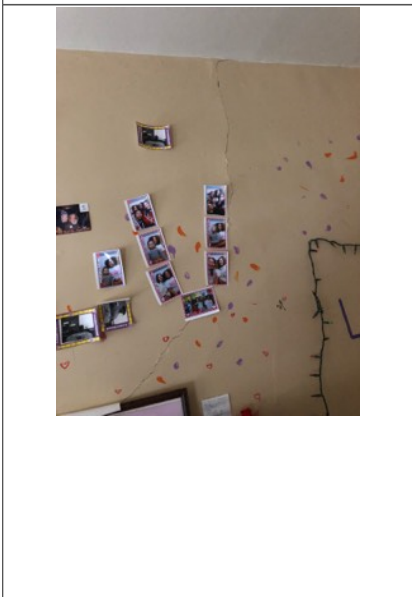
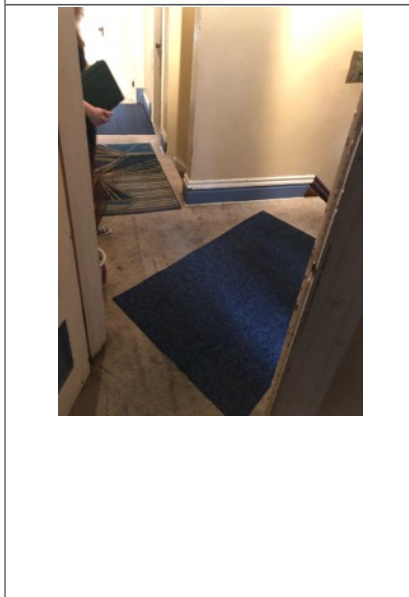
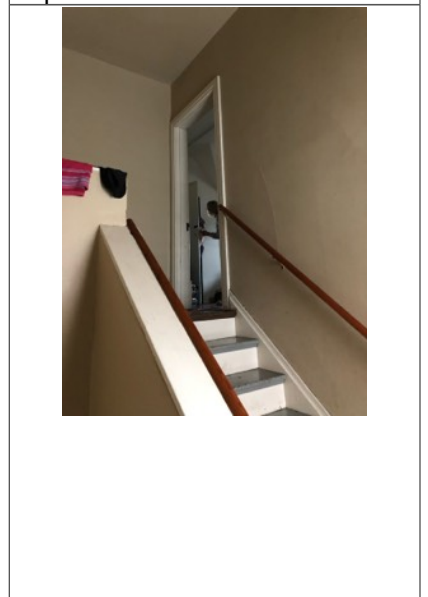
Several holes and cracks in walls of steps upstairs

Owner shut off electric to entire upstairs, evidence of previous overheating and potential fire damage at outlet. Recommend electrician replace/repair and perform necessary safety checks before returning power to upstairs

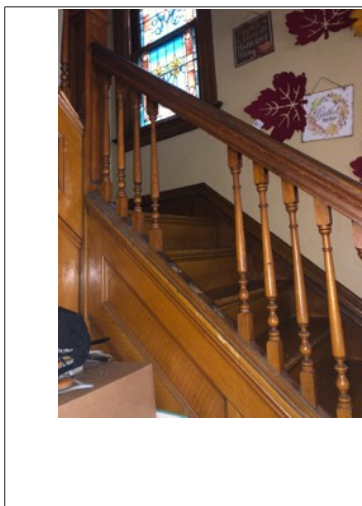
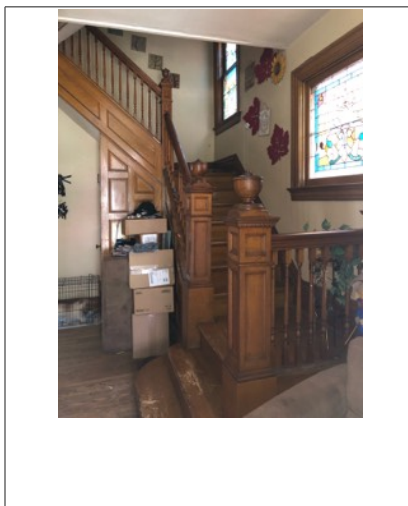
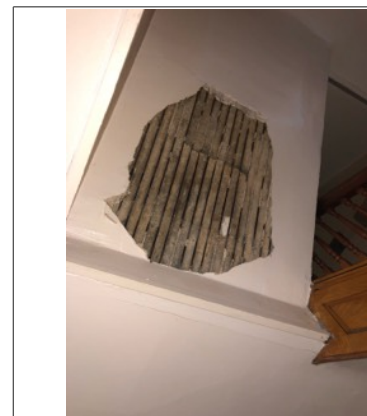
- None
Condition Satisfactory Marginal Poor Loose/Missing
Handrail Satisfactory Marginal Poor Safety hazard Hand Rail/Railing/Balusters recommended
Risers/Treads Satisfactory Marginal Poor Risers/Treads uneven Trip hazard
Comments Large section of handrail on main staircase is missing balusters

Area under staircase at ceiling is missing large section of plaster. Recommend repair

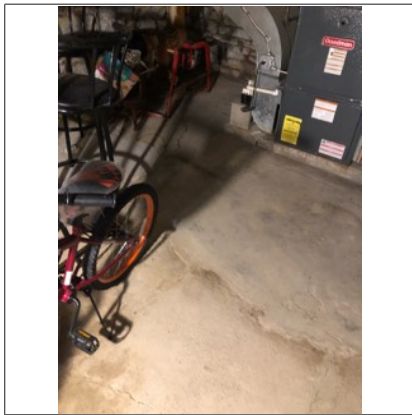
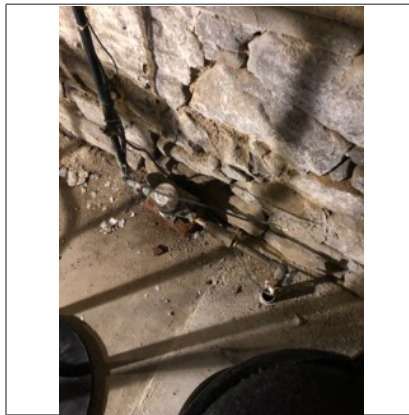
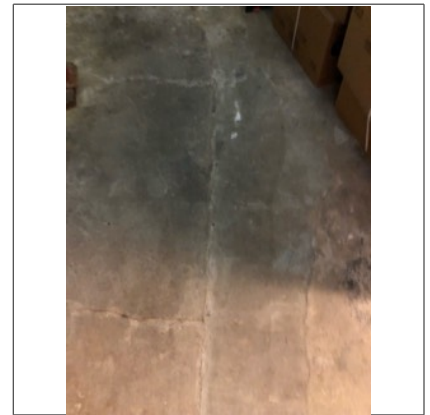
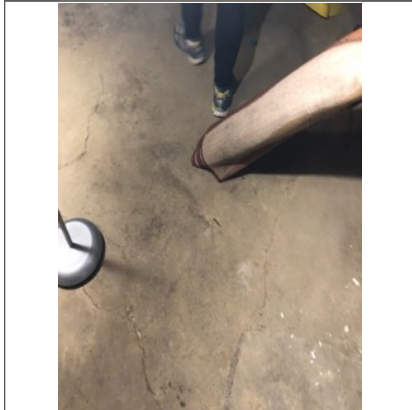
Material Concrete Dirt/Gravel Not Visible Other: .
Condition Satisfactory Marginal Poor Typical cracks Not Visible
Comments Floor had some cracking and movement, recommend repair
Photos

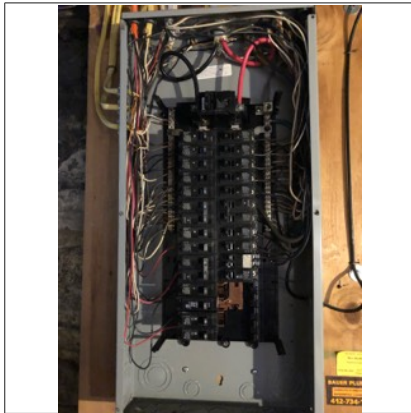
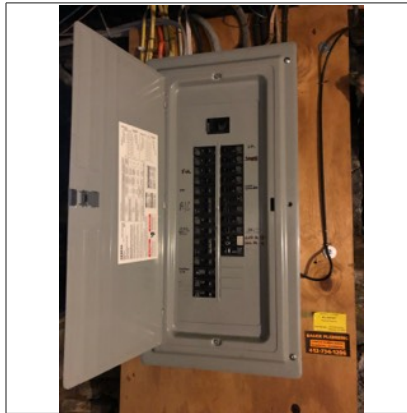
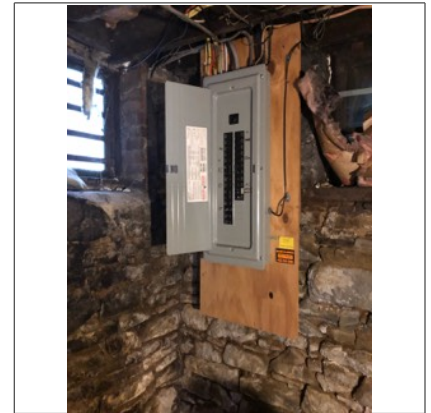
Main wires are aluminum - recommend no-oxidation paste be applied to wires to prevent corrosion

Outlet in living room had hot and neutral wired incorrectly.

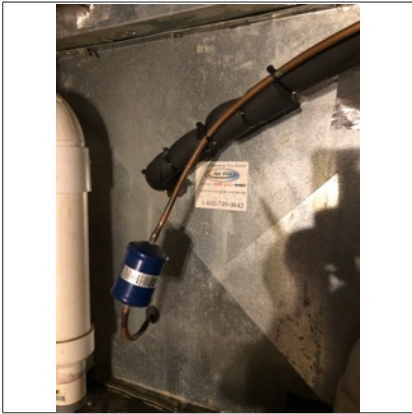
- N/A
General Central system Wall unit
 Age:5
Evaporator coil Satisfactory Not Visible Needs cleaning Damaged
Refrigerant lines Leak/Oil present Damage Insulation missing Satisfactory
Condensate line/drain To exterior To pump Floor drain Other:
Secondary condensate line/drain Present: Yes No Needed: Yes No Primary pan appears clogged
 Recommend technician evaluate
Operation Differential: 14.3
Condition Satisfactory Marginal Poor Recommend HVAC technician examine/clean/service
 Not operated due to exterior temperature
Comments Recommend an HVAC contractor examine.
