Home Inspection Report

Thursday, August 22, 2019

MATTERHORN PROPERTIES LLC

08222019

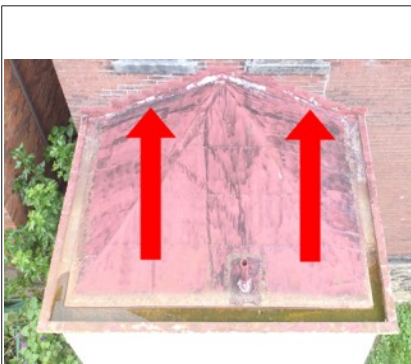
Flashing shows signs of serious rusting, recommend replacing.

Flashing at roof edge and siding is in need of repair and sealing

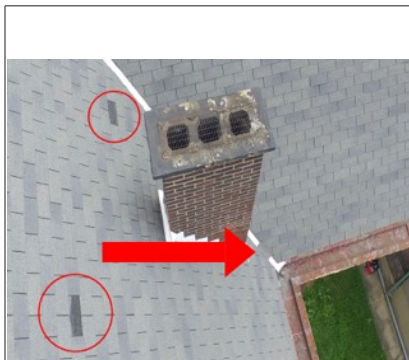
Missing tabs or shingles recommend repair or replacement.

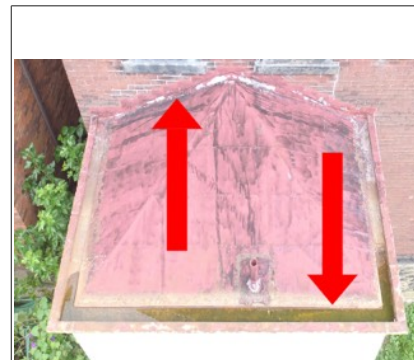
Poor flashing
Gutters in need of cleaning

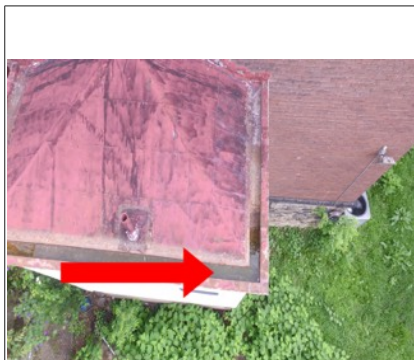
Gutters are in need of cleaning

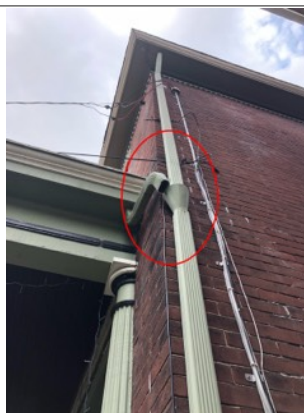
Downspout is not attached properly to other downspout for adequate drainage. This condition results in runoff puddling at foundation and contributing to water penetration in the basement

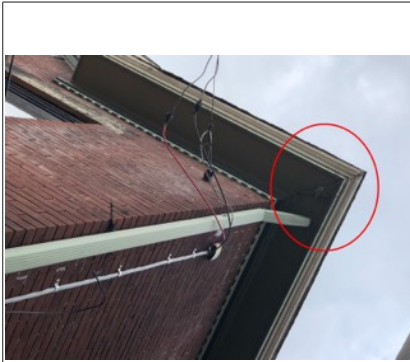
Comments Soffit damaged/rotted, recommend repair

Entire soffit and trim in need of painting and repair

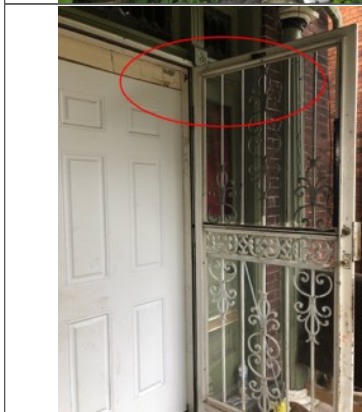
Front storm door doesn't have safety door closer

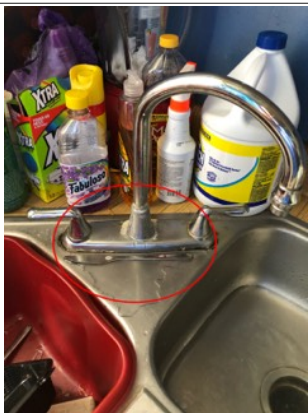
Faucet leaks at base

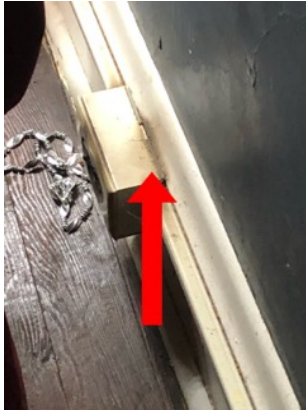
Owner shut off electric to entire upstairs, evidence of previous overheating and potential fire damage at outlet. Recommend electrician replace/repair and perform necessary safety checks before returning power to upstairs
