Home Inspection Report

Thursday, August 22, 2019

MATTERHORN PROPERTIES LLC

08222019

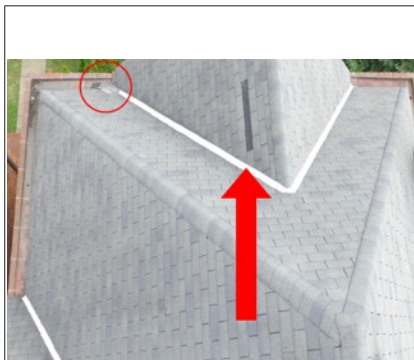
Missing tabs or shingles recommend repair or replacement.

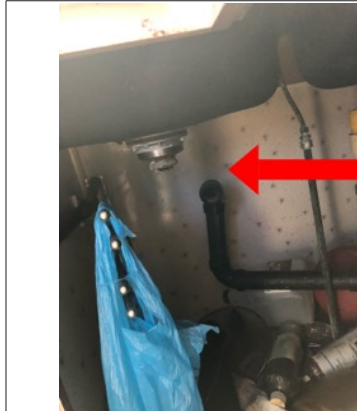
Drains show signs of leakage recommend repair

Left side of sink has no connection to drain. Connection is needed and proper P Trap installed. Sewer gases will enter living space until proper connection is performed

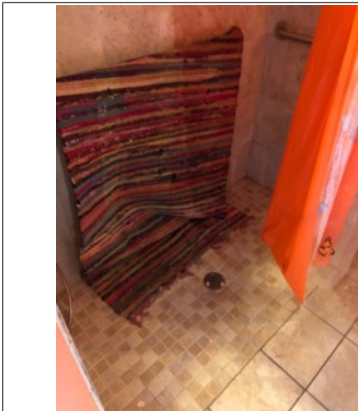
- Heat source present** Yes No
- Exhaust fan** Yes No Operable: Yes No Noisy
- Comments** Moisture stains present.
Damaged walls recommend repair
Damaged ceiling recommend repair
Recommend venting exhaust fan to exterior
Several areas on the ceiling and walls have active moisture stains, recommend roof/gutters repaired and walls/ceiling repaired.

Water damage

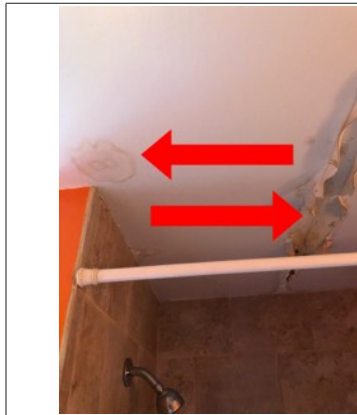
Water damage and staining

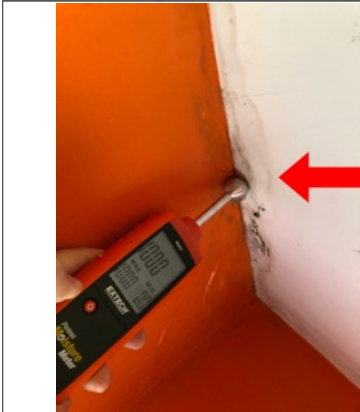
Water damage and moisture present.

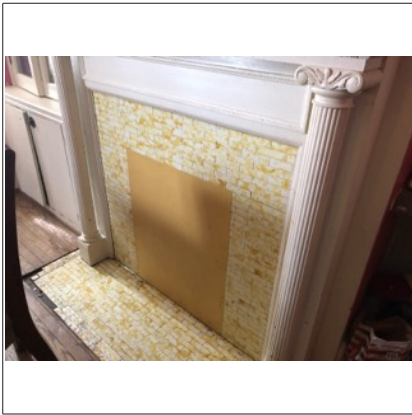
Comments Walls and ceiling contain chipped paint and cracking in plaster. Recommend repair and paint

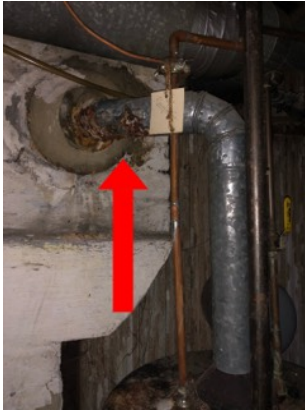
Comments Excessive rust present on vent pipe - recommend repairing and/or replacing

Vent pipe is rusted and has a hole. Exhaust leaks into basement and is not venting properly. Backdraft upon heater fired up. Recommend licensed repair SAFETY HAZARD

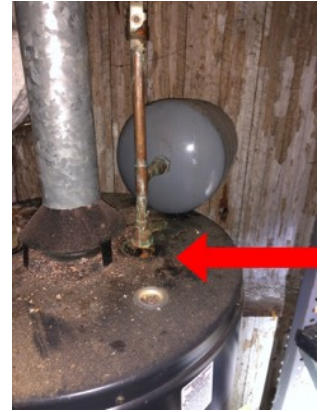
Backdraft
